# **Trip Report 2003 Annual Inspection of Site A/Plot M, Cook County, Illinois, Decontamination and Decommissioning Program Site**

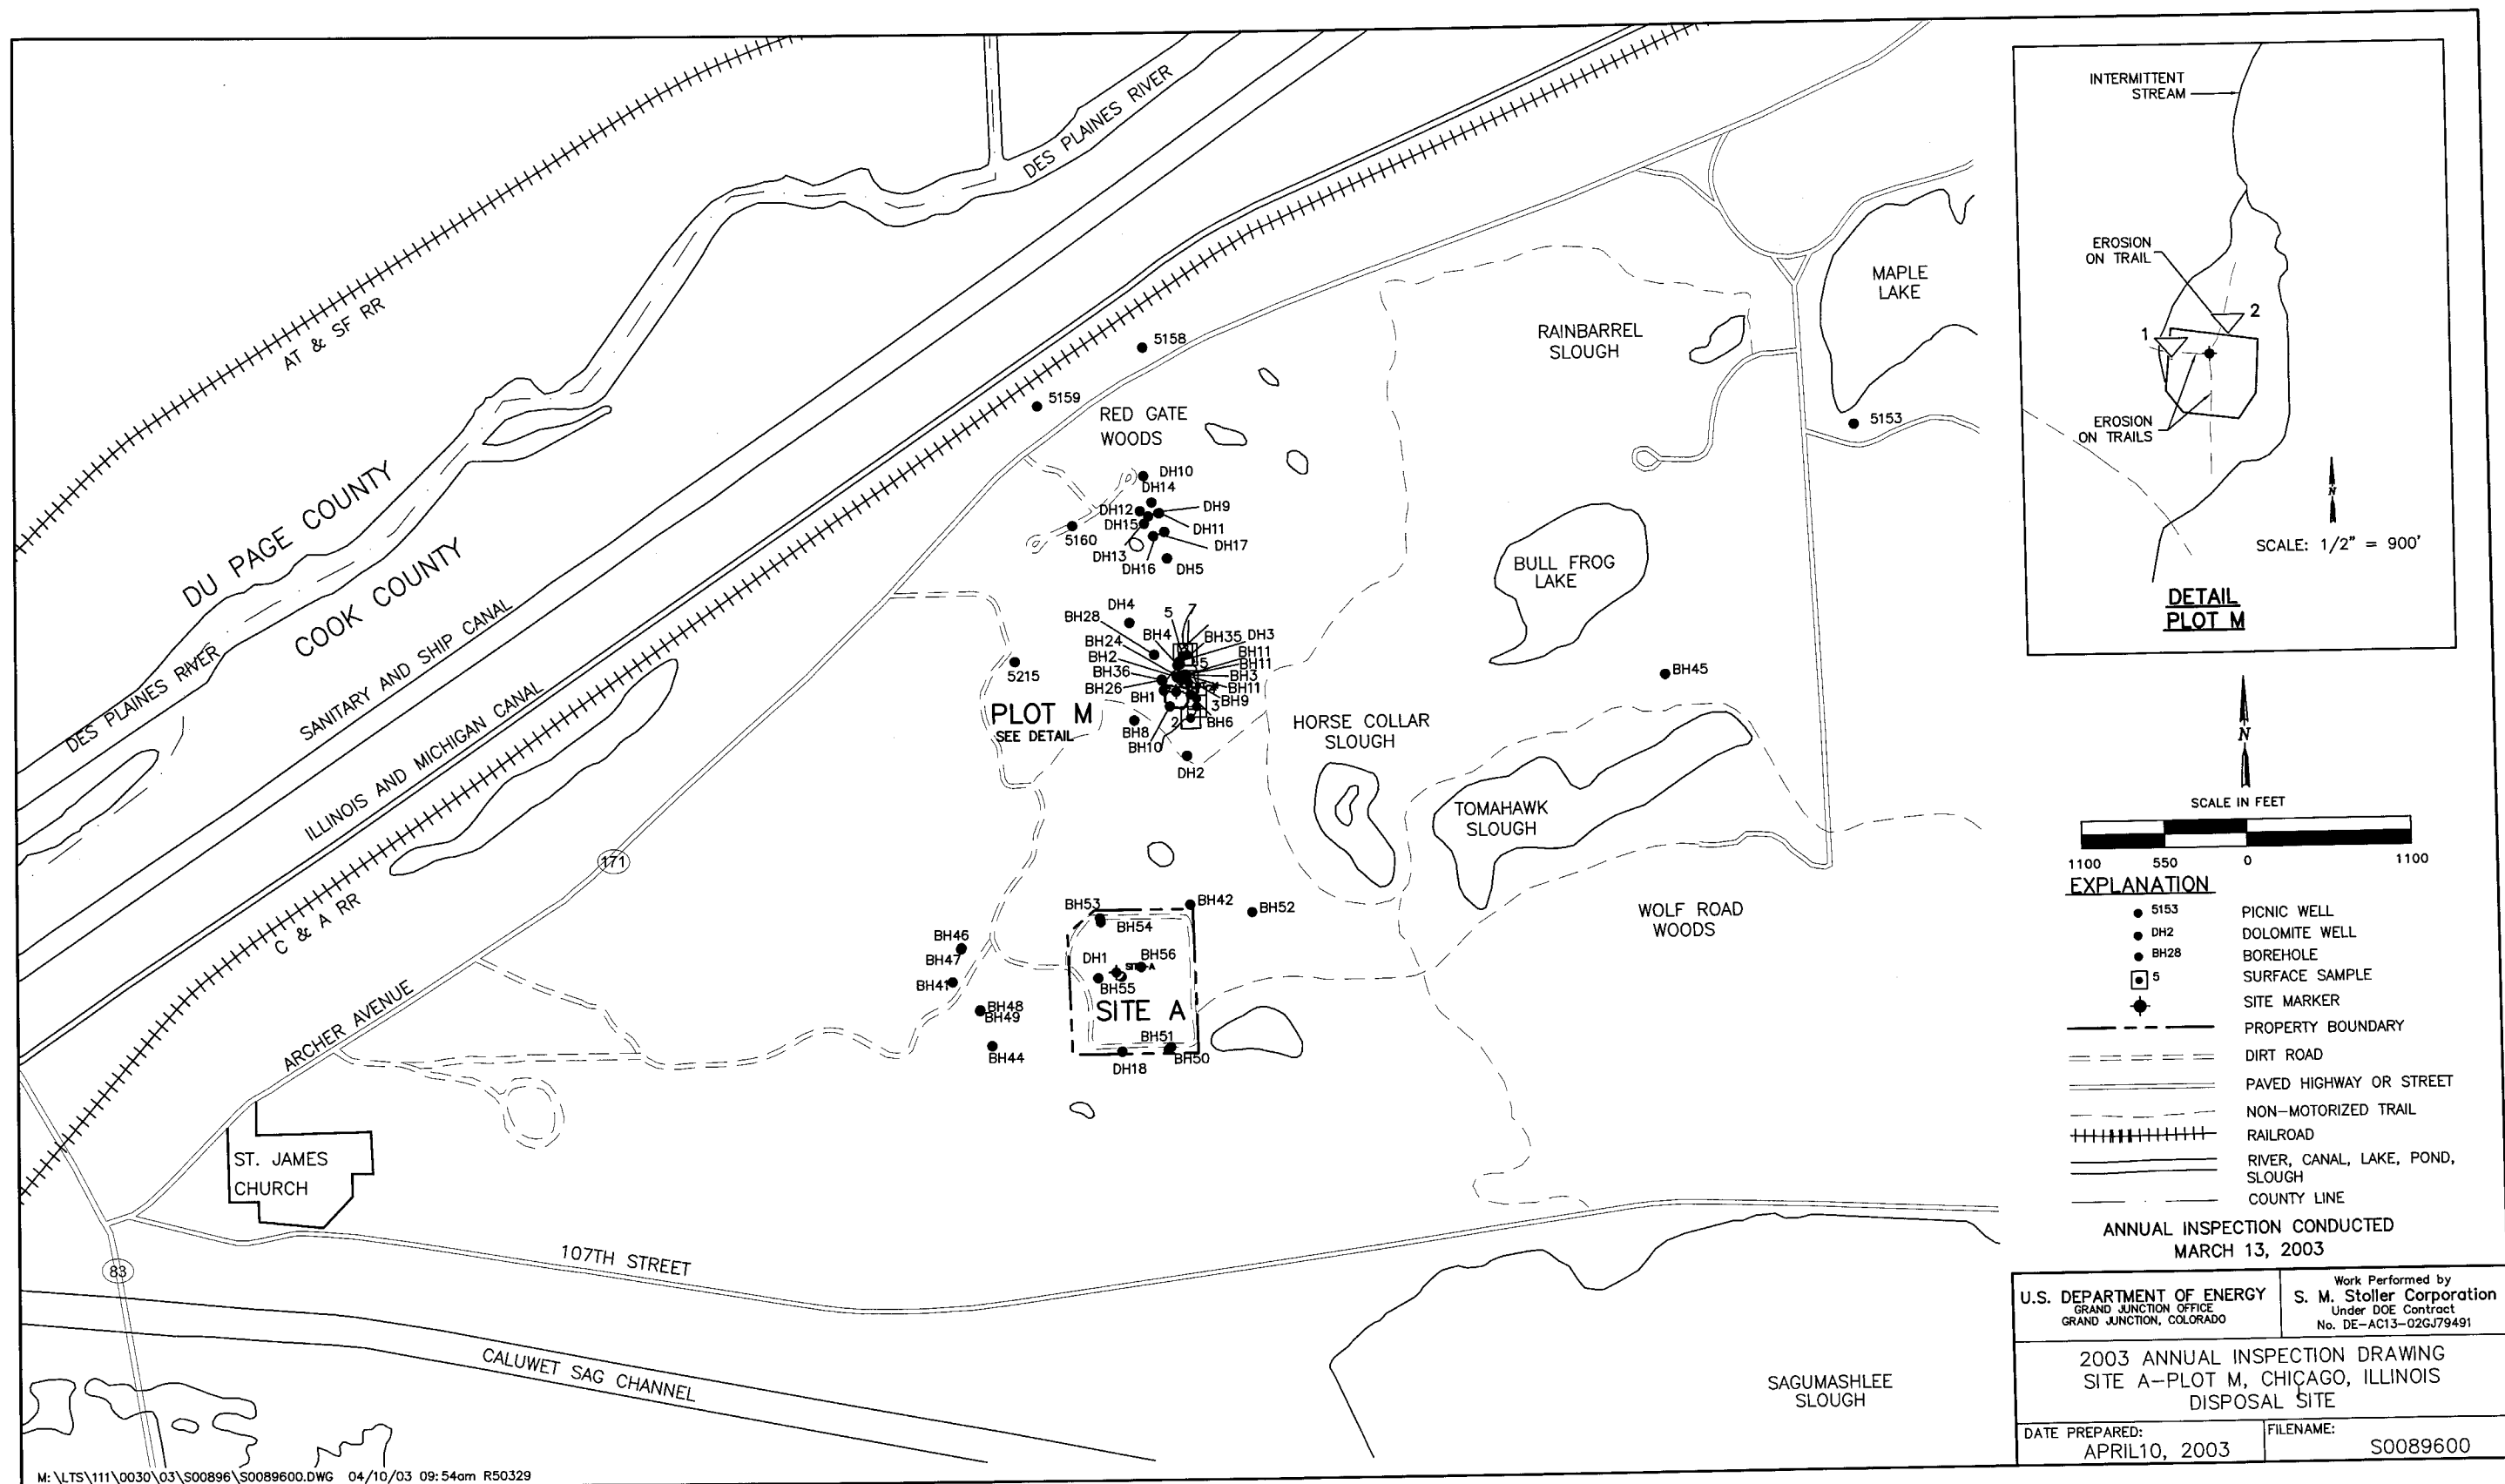
Erosion was noted along the paths crossing Plot M between the monument and the north, south, and west sides of the site (PL-1 and PL-2). The cell is not yet threatened but erosion is approximately one foot deep and the earth cover over the concrete cap is only two feet thick. Although erosion does not appear to have increased appreciably during the past year, the LTSM Program should consider controlling measures to reduce the likelihood of the concrete cap becoming exposed. The ANL representative requested the Palos Forest Preserve District repair the erosion in 2002 but the work had not been conducted.

Erosion has occurred along the paths crossing Plot M.

SAM 03/2003. PL-2. Mark Reed inspecting erosion trail on Plot M.

**Recommendation:** Enough traffic passes over these paths to preclude successfully repairing the erosion by filling the depression with soil and reseeding. Therefore, inspectors recommend placing crushed rock in the depression mixed with soil, and reseeding. A letter should be written to the Palos Forest Preserve District requesting them to repair the erosion.
